# CASE HISTORY

## ECP HELICAL TORQUE ANCHORS™

### Tieback Anchors Repair Tilting Foundation Walls Denver, Colorado

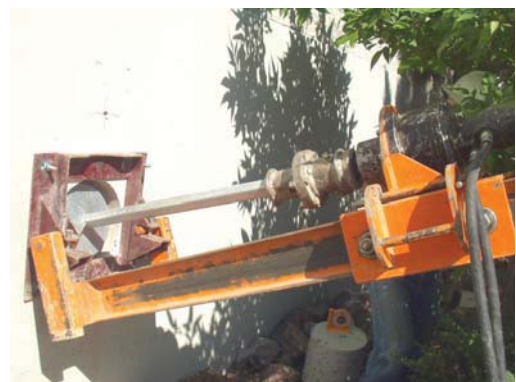
From the top: Soil removal was accomplished by conveyor as workers dug behind the stem walls. A helical tieback is installed at the specified angle.

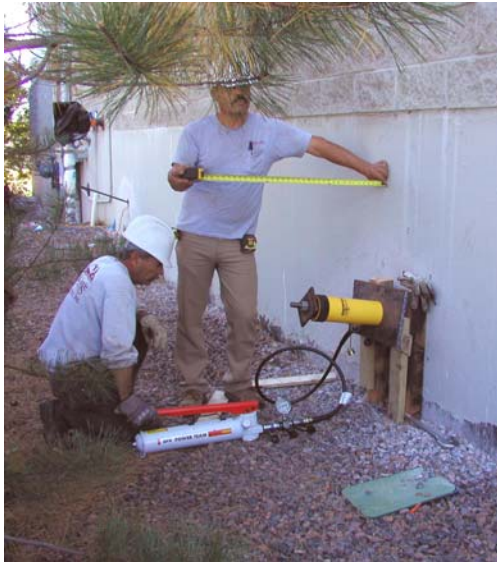
The entire wall was restored gently and evenly by using multiple hydraulic jacks.

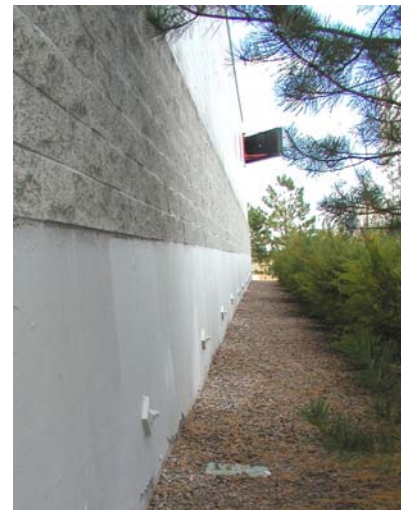
Finally, here is a view of the restored wall. The small wall plates are the only evidence of the work.
