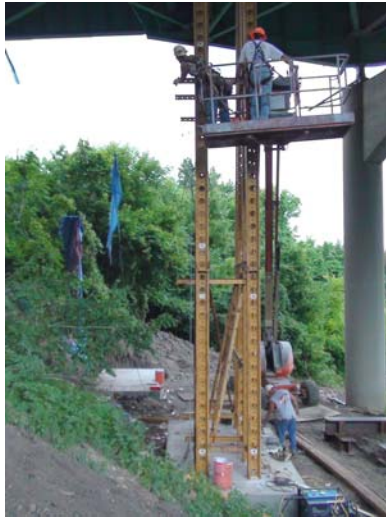
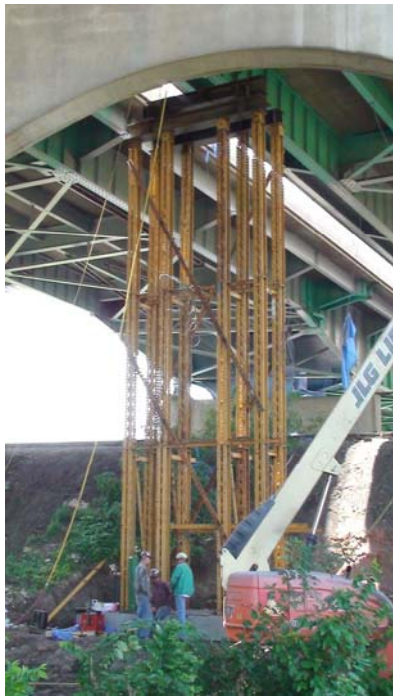
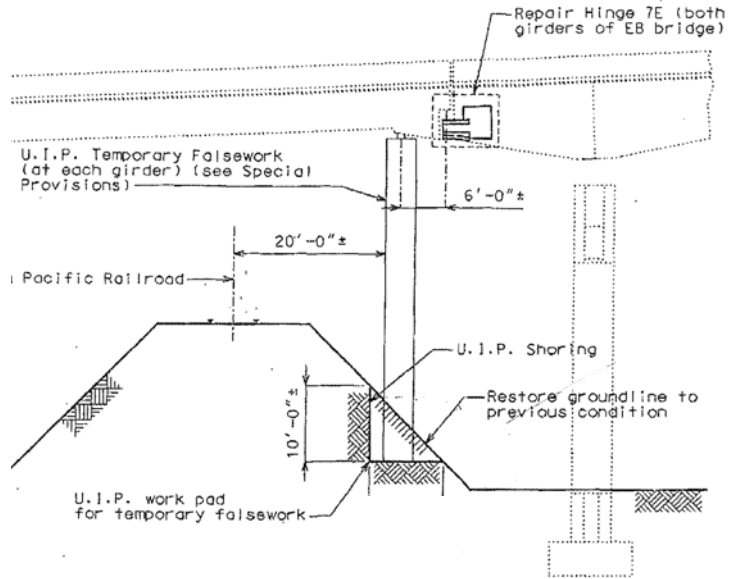
These photographs show the falsework in place under the bridge, the steel beams under the bridge girder and one of the concrete footings.

Once the piles were installed and the concrete footings cast, the falsework steel framing was installed. The weight of the bridge was transferred to the temporary supports as shown in the photograph above.

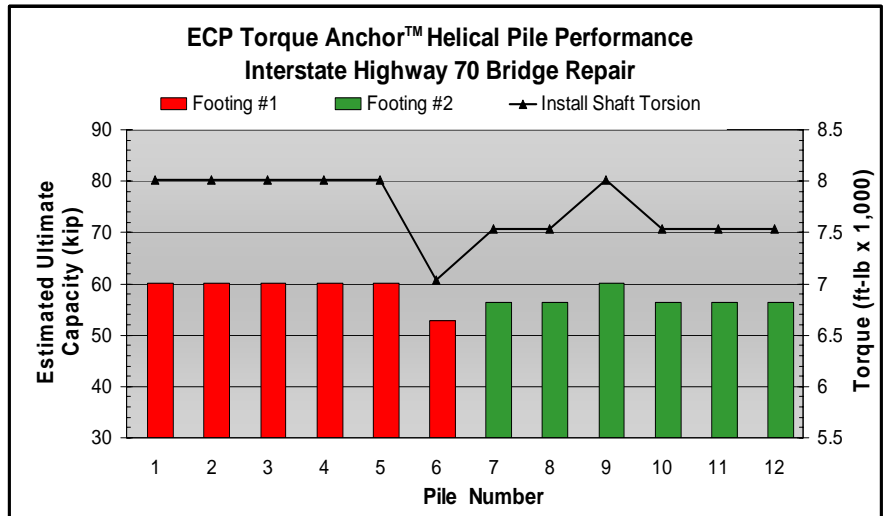
The 3-1/2 inch diameter tubular pile shafts were configured with two helical plates. The lead of the pile had a ten inch diameter helical plate near the tip of the shaft followed by a twelve inch diameter helical plate located 30 inches higher on the shaft. The lead shaft length was five feet. Five extension sections that measured ten feet long were attached to each lead along with one five foot extension to provide sufficient pile depth to reach the depth of the load bearing shale stratum.

The foundation underpinning plan called for six helical piles at each of the proposed concrete footings. The piles were installed to a depth from 57 to 60 feet below grade into a stratum of shale.

The piles were advanced into the soil using a 12,000 foot-pound hydraulic torque motor that was powered by a mini-excavator. A boulder was encountered during installation of one of the piles, which required a slight modification to the original pile layout plan.

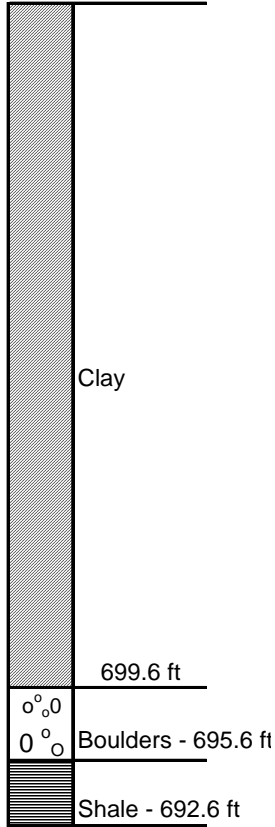
SOIL LOG - 7

feet of very soft to medium stiff clay. With groundwater at 16-1/2 feet, helical piles seemed like an economical solution for foundation support for two footings that measured six feet by sixteen feet and two feet thick.

752.6 ft

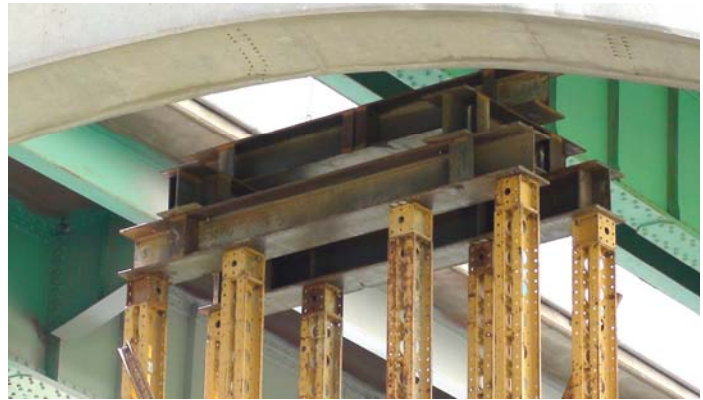
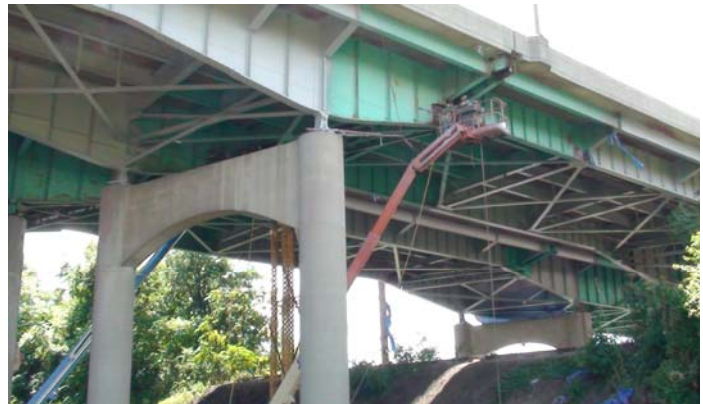
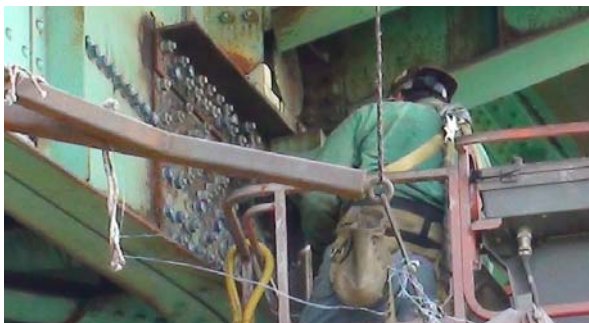
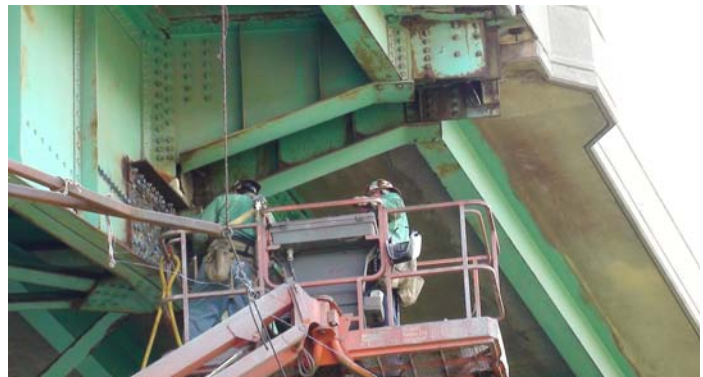
With the tongue and groove joint now free, workers were able to remove and replace the hinge plates. The delicate process took place on a platform high in the air. A close view of the new hinge plate is shown below.
