# CASE HISTORY

## ECP STEEL PIERS™ STANDARD MODEL 350

### Dixie National Forest Service Office, Cedar City, UT

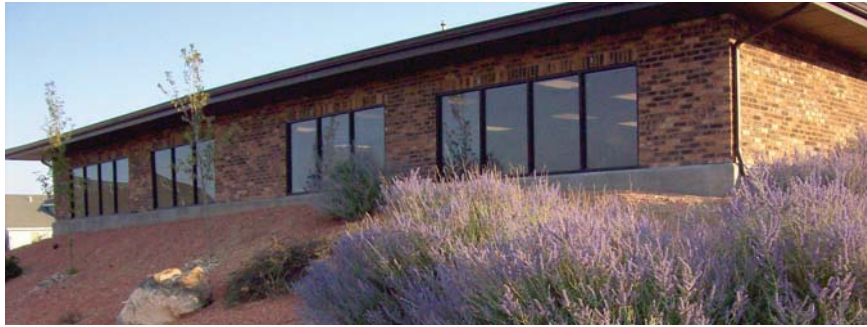
Earth Contact Products' Steel Piers™ were selected to support and restore this office building after the owner determined that the entire structure had settled between 1/8 inch and 3-5/8 inches. The settlement was most likely caused by consolidation of fill soil on the lot. The contractor installed ninety seven ECP Model 350 Steel Pier™ systems to recover lost elevations.

Photographs: At the top is a view of the settled structure showing the large depth of fill below the foundation. At top right the excavations are prepared at pier locations along the perimeter of the structure. Above right shows how the foundation was prepared for mounting the pier bracket. The technician is smoothing the face of the stem wall. The bearing area under the footing was also similarly prepared. At right a technician installs one of the drive stands that were used to advance the pier pipe through the soil to end bearing.

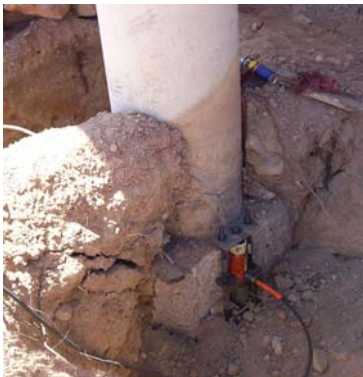
Photographs: Above the technicians are installing pier pipe using quiet and vibration free hydraulics. At left center, the structural load is being transferred from the concrete footing to the pier systems using multiple hydraulic jacks. At left, one can see how the columns were lifted along with the building. One steel pier was situated on each side of the column footing making lifting the columns a simple procedure. The photo at bottom left shows how recovering the lost elevation was accomplished. All hydraulic jacks were connected together through a manifold system and actuated using electric pumps for gentle and uniform lifting. Below are views of two Model 350 ECP Steel Pier™ placements. Notice amount of lift accomplished on this project and the final configuration of the pier system.
