# CASE HISTORY

## ECP HELICAL TORQUE ANCHORS™

### Tieback Anchors Repair Tilting Foundation Walls Denver, Colorado

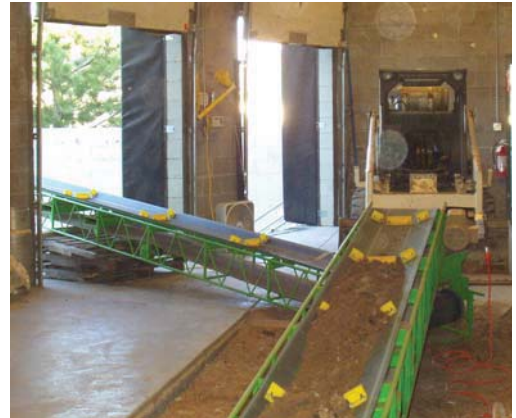
The owners of this chain store contacted JR Harris & Company Structural Engineers after distress along the walls were noticed and large cracks in the floor caused an unsafe working environment. The building was constructed on a lot containing fill soil. In addition, the foundation stem wall was exposed on the exterior and filled with soil on the interior to provide for a level floor. The force of the soil under the slab pressed against the stem walls causing outward rotation of the walls. The project required removing a portion of the concrete floor and the soil that was below the slab. Helical Torque Anchors™ were installed to provide supplemental lateral wall support and to restore the walls back to plumb.

ECP Model TAF-150 solid square shaft Torque Anchor™ tiebacks were installed through the wall and into the soil below the structure. The tieback anchors were installed a distance of 25 to 35 feet under the building before reaching suitable shaft torsion to provide a working capacity of over 7,000 pounds at each placement.

Once the Torque Anchor™ tiebacks were installed, the wall was moved 3" to 4" back to plumb using a series of hydraulic jacks. The only evidence of the work is the row of wall plates, threaded bars and nuts that are visible along the exterior surfaces of the stem walls.
