## CASE HISTORY

### ECP TORQUE ANCHORS™ CONCRETE SLAB REPAIR

#### Emergency Battery Packs Cause Slab to Settle

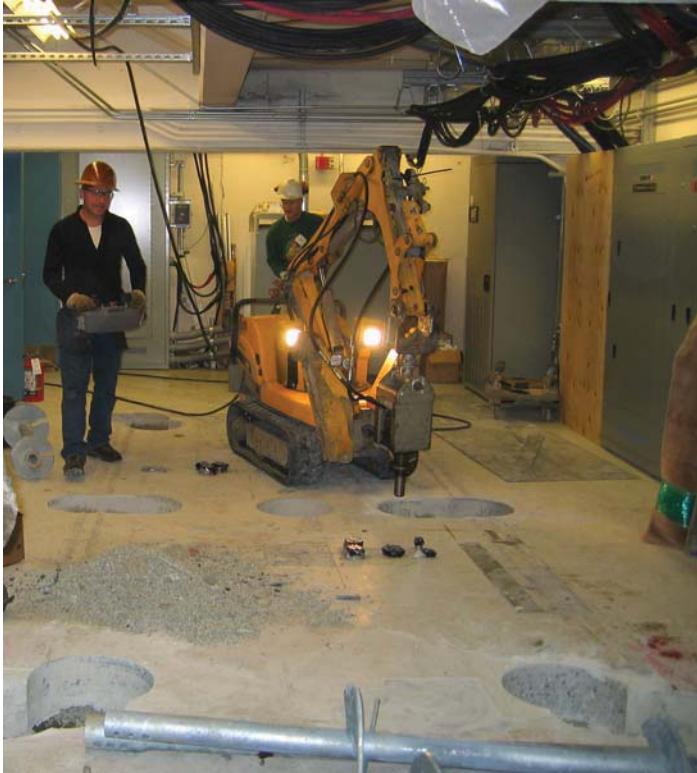
A major internet entertainment provider called a contractor for help with slab settlement in their emergency battery room. The engineer attributed the distress to the racks of wet cell batteries causing extremely heavy floor loads on the slab.

After investigating the advantages and disadvantages of several underpinning systems, Pile King proposed to the owner to install ECP Torque Anchors™ as the best solution to provide supplemental support to the affected area. However, this solution was not without challenges. The battery room was located on the lower level of the building; the room had low overhead clearance and was located some 300 feet from the nearest entrance. In addition, the work had to be completed rapidly because once the back-up power system was

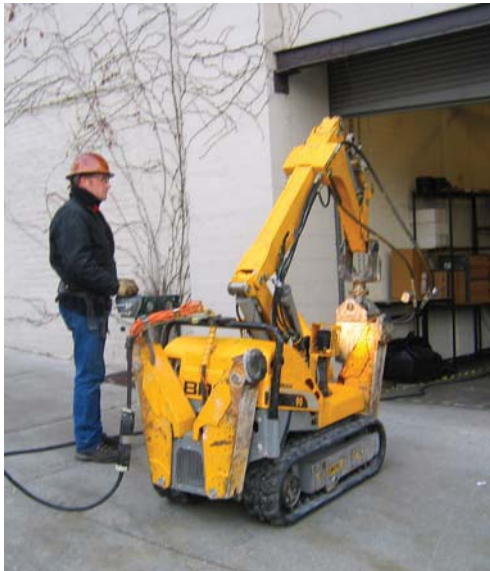
Photographs: At the top is a view showing the tight area of work in the emergency battery room. Access holes for the helical piles have been drilled in the floor. Unfortunately, obstructions required relocating several placements. At left is a view of the Brokk 90 Mobile Driller. The machine was fitted with an Eskridge 4K5 hydraulic gear motor that provided up to 4,500 foot-pounds of torque for the rotary installation of the piles.

Construction noise or vibration was not permitted because normal business activities could not be disturbed during repair operations. The key to landing this project was a plan to use a Brokk 90 Mobile Drill machine. It was small enough to gain access the work area. The machine operated on electric power; so when it was running, there was no motor noise, fumes or vibration to disturb the building's occupants. By using the Brokk machine, the project was able to be completed in only 1-1/2 days instead of the original plan of working from 6:00 to 11:30 in the evening for more than a week.

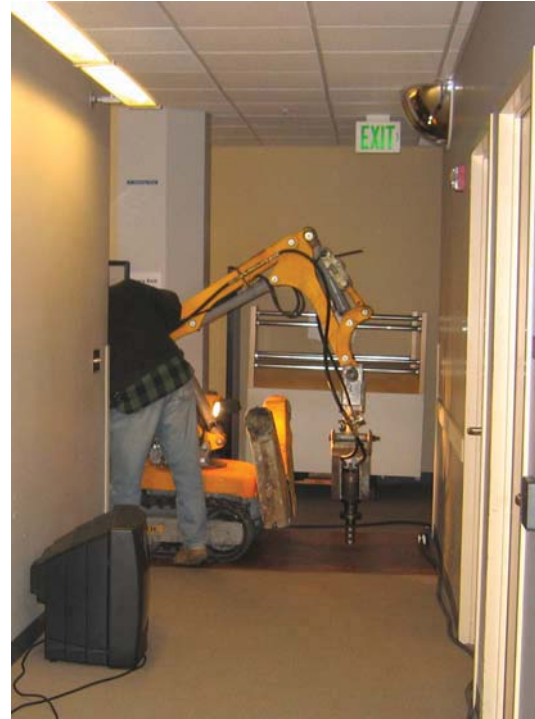
Photographs: Above right shows the maneuverability of the Brokk machine. Here the workers are guiding it through the office space on its way to the emergency battery room on the lower level. Below are two views of the job site. The emergency battery packs occupy the area where the floor has been drilled. ECP Helical Torque Anchors™ were installed under each battery array, which provided additional working load support of 15,000 pounds per pile placement.
